Final Research Report

ANALYSIS AND DESIGN OF WIRE MESH/CABLE NET SLOPE PROTECTION

1. REPORT NO. WA-RD 612.1		2. GOVERNMENT ACCESSION NO.		3. RECIPIENT'S CATALOG NO.	
4. TITLE AND SUBTITLE ANALYSIS AND DESIGN OF WIRE MESH/CABLE NET SLOPE PROTECTION				5. REPORT DATE April 2005

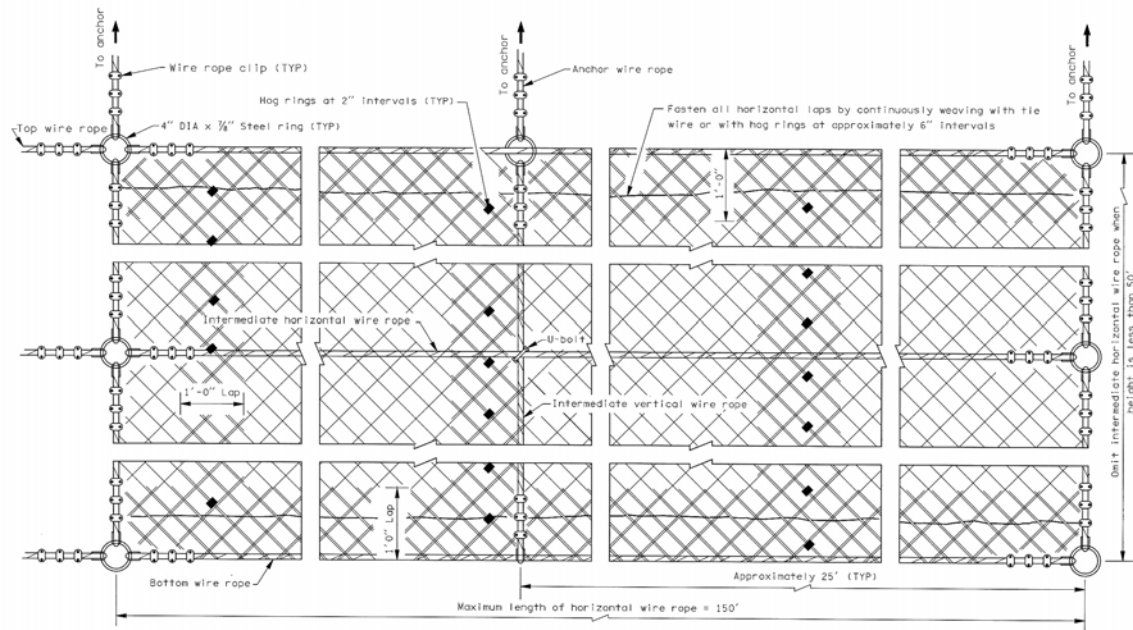
Figure 1-1. Schematic drawing shows basic elements of a drape mesh system.

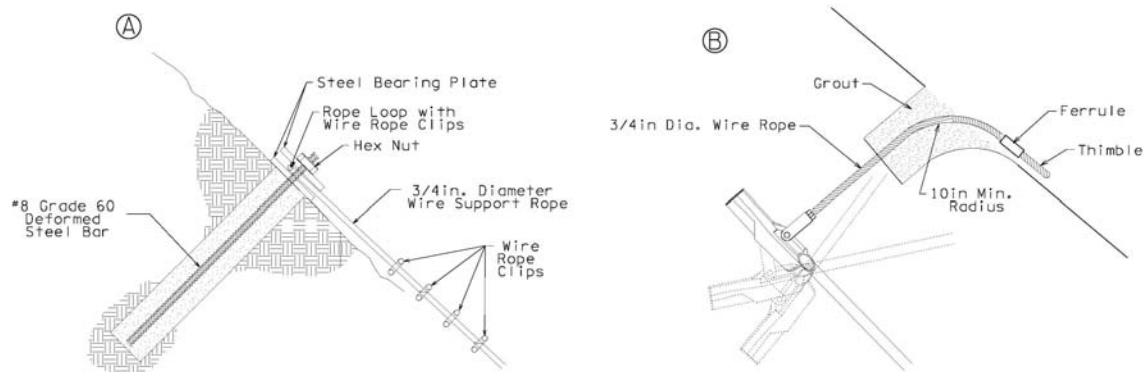
Figure 1-2. Typical rock anchors include (A) deformed steel threaded bar, and (B) a wire rope tendon.

Anchors can be grouped into those for intact rock or soil conditions. Rock anchors most commonly consist of a solid core, deformed steel, continuously threaded bar (Figure 1-2A) or, more recently, a wire rope tendon (Figure 1-2B) placed in a fully grouted hole. Some of the more common soil anchors include deadman-type, wire rope tendons, driven and/or grouted steel bars, hollow core drillable-groutable bars (Figure 1-3A), and MANTA RAY® (Figure 1-3B) anchors.

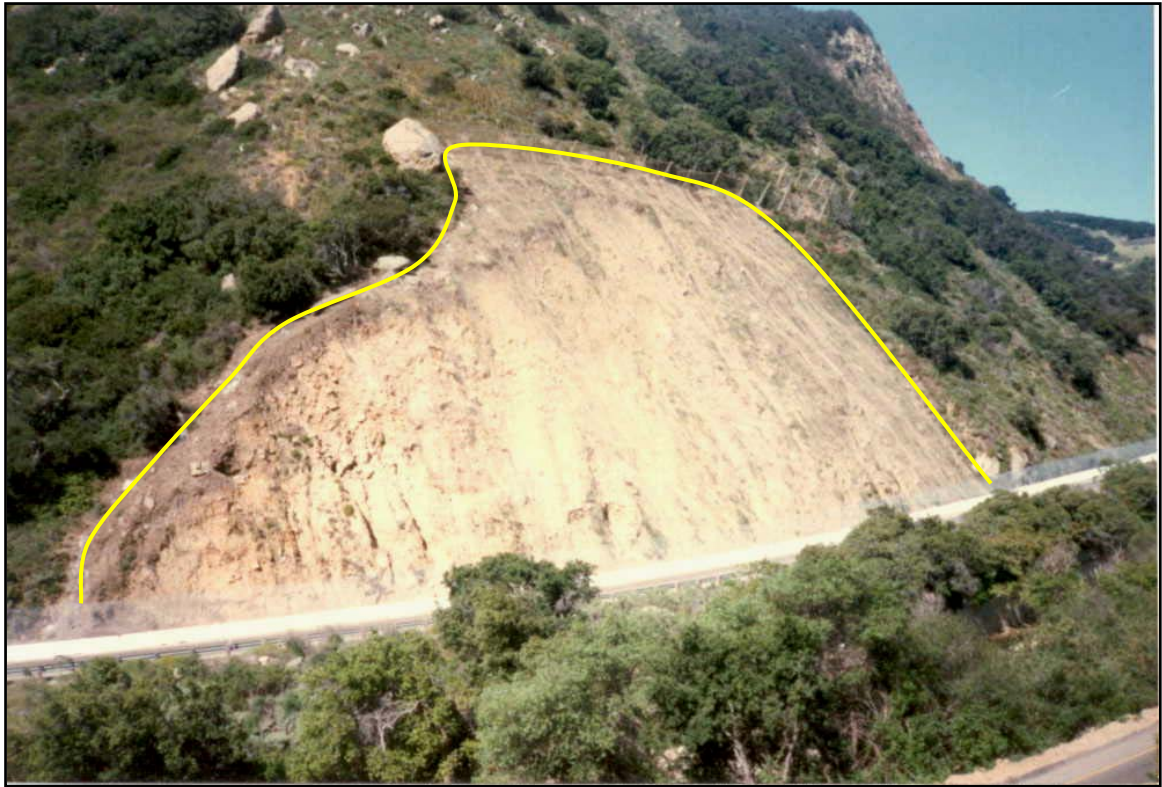
Figure 2-1. Slope condition before mesh installation; yellow line delineates coverage area

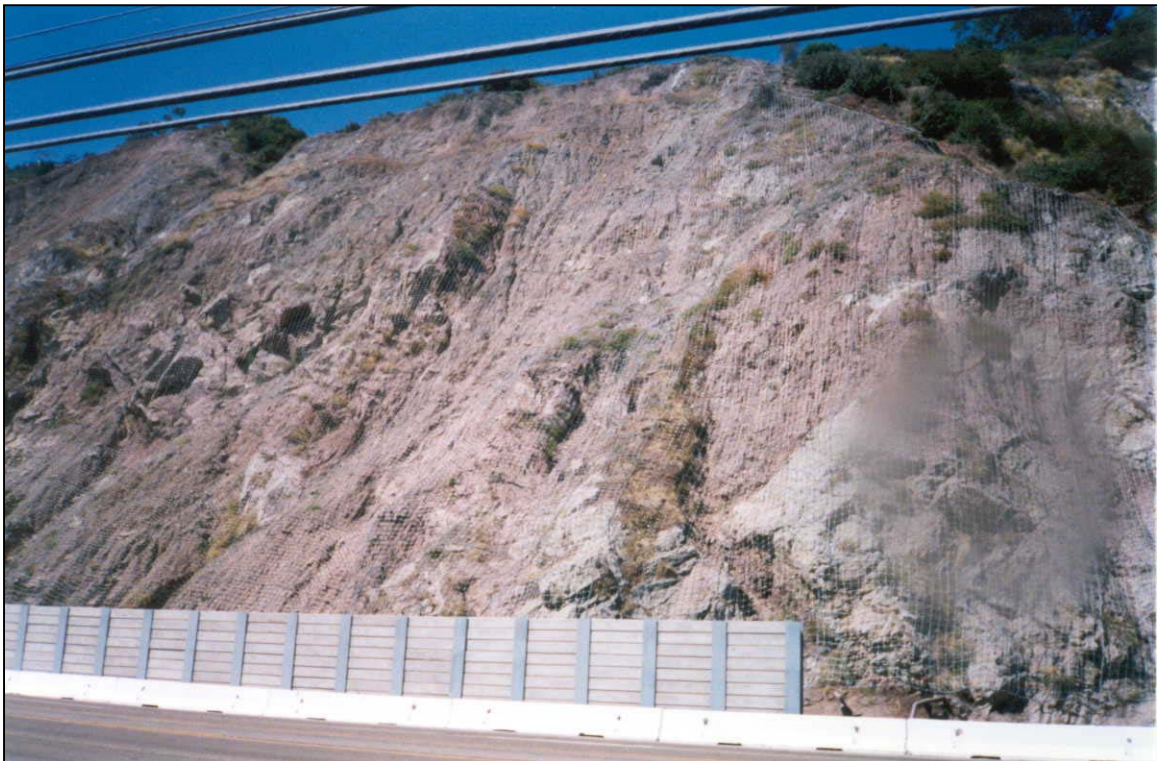
Figure 2-2. Slope condition after the slope was covered with a cable net.

small-scale slope instabilities such as rockslides, debris flows, and debris avalanches (Figure 2-2). The material consists of fractured sandstone overlain by Quaternary landslide deposits (angular fragments of sandstone, gravel, and silt). The slide is active and creeps during wet periods. The cut slopes have slope ratios of from near vertical to 1H:1V. Although some catchment area is available, rockfalls 3 to 6 feet in dimension, and small debris flows and rockslides 25 cubic yards in size have reached the roadway.

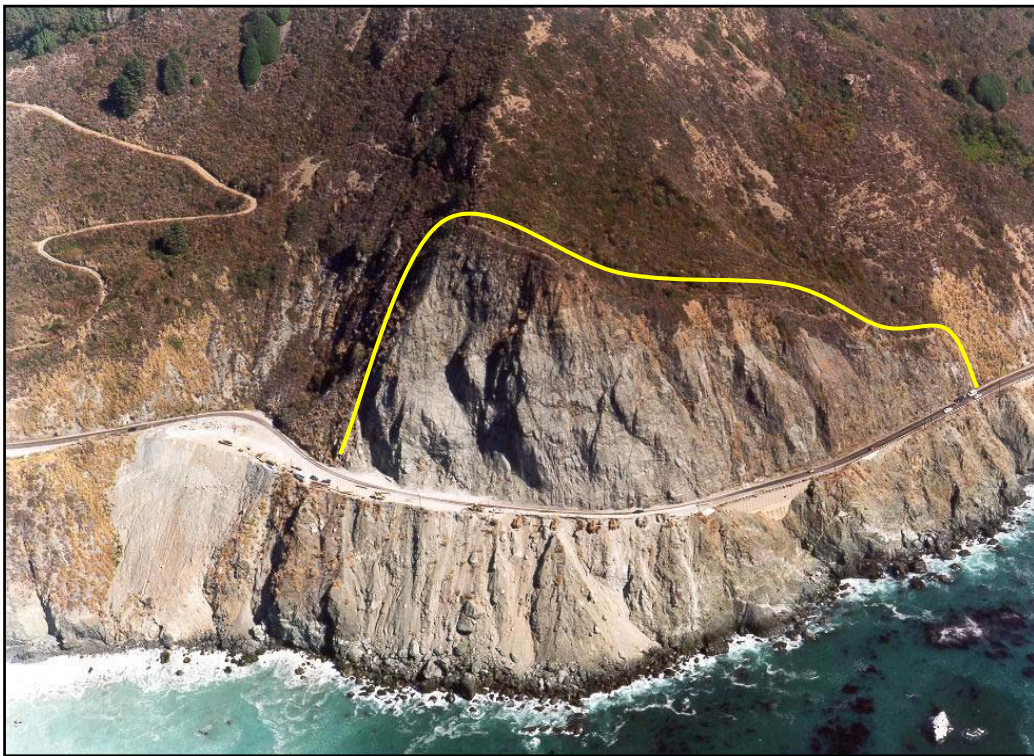
Figure 2-3. Slope condition after the mesh installation (yellow line) at Rain Rocks site.

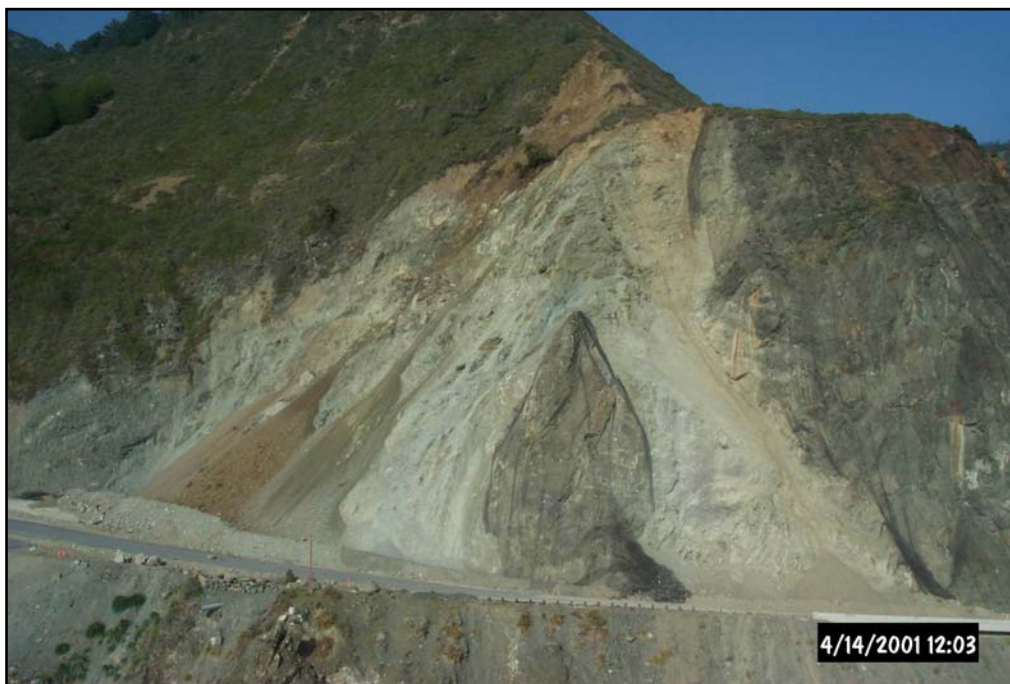
Figure 2-4. Slope condition after slope instabilities destroyed the hexagonal wire mesh installation at Pitkins Curve adjacent to Rain Rocks chute.

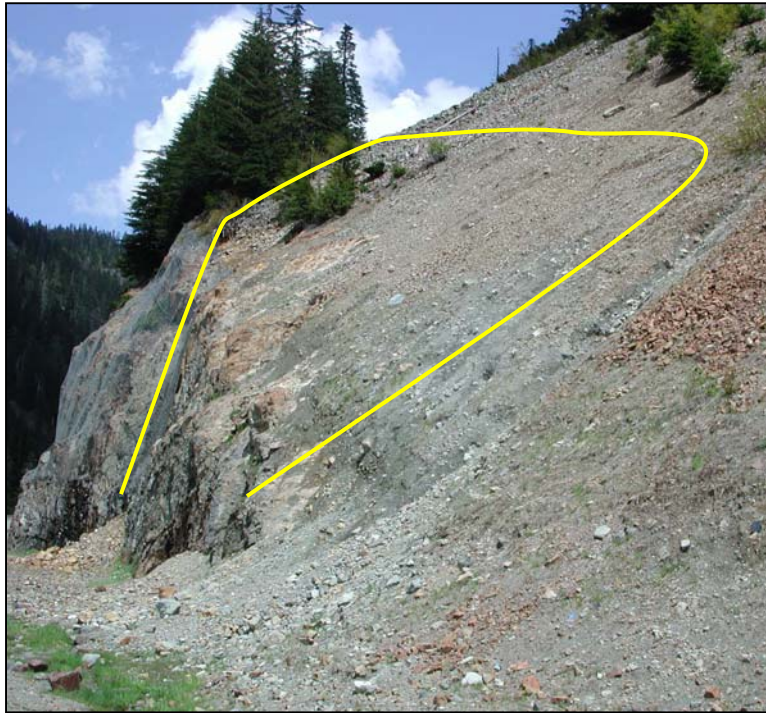
Figure 2-5. Slope configuration for the western portion of the 1998 cable net installation (yellow line). Extreme snow loads during the winter of 1998/99 caused most of the cable net anchors located along the top of the installation to fail.

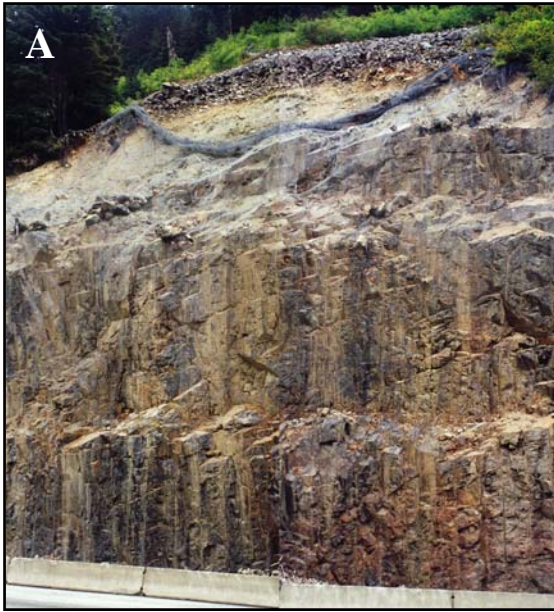
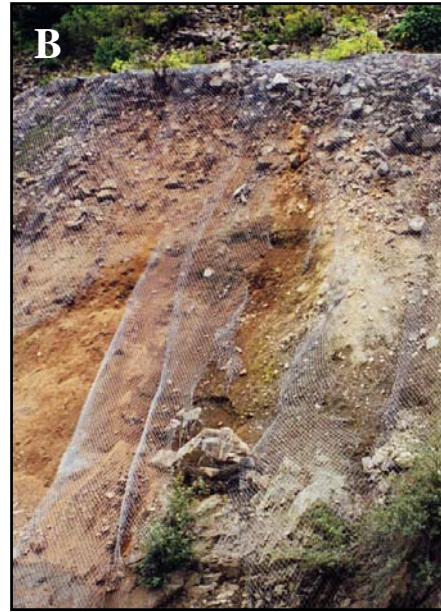
Figure 2-6A. Failure in the eastern portion of the 1982 chainlink installation. Active erosion undermined the top row of anchors. Pockets of debris accumulated along intermediate support ropes. Figure 2-6B shows localized rupture by a 3- to 4-foot-diameter boulder that initiated from the bouldery talus shown at the top of photograph.

By the mid-1990s, the eastern portion of the initial chainlink installation was in very poor condition (figures 2-6A and 2-6B). Erosion had exposed many midslope and top anchors. Debris accumulation behind the support ropes and large boulders had caused extensive punctures and ruptures of the system.

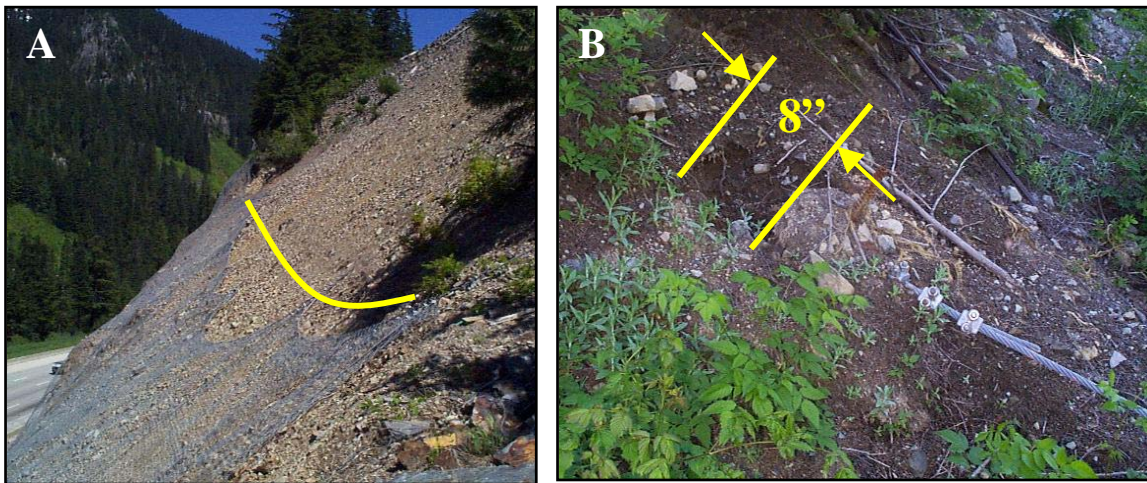
Figure 2-7A. Failure of the cable net system in the western portion of the site in July 1999. The yellow line is the approximate location of the top of the cable nets as installed in 1998. Figure 2-7B shows deformation of the ground where loads exceeded passive earth pressure, causing 8 inches of anchor deflection.

anchors, causing severe ground deformation (figures 2-7A and 2-7B). The ultimate capacity of the anchors in shear was around 35,000 lbs. Slightly lower-than-design grout strengths and difficulties with grouting in the cobbles and boulders often void of matrix may have contributed to the anchors failing in pullout. Some of the anchors where passive earth pressures were exceeded had been installed vertically, rather than normal to slope, resulting in diminished capacity.

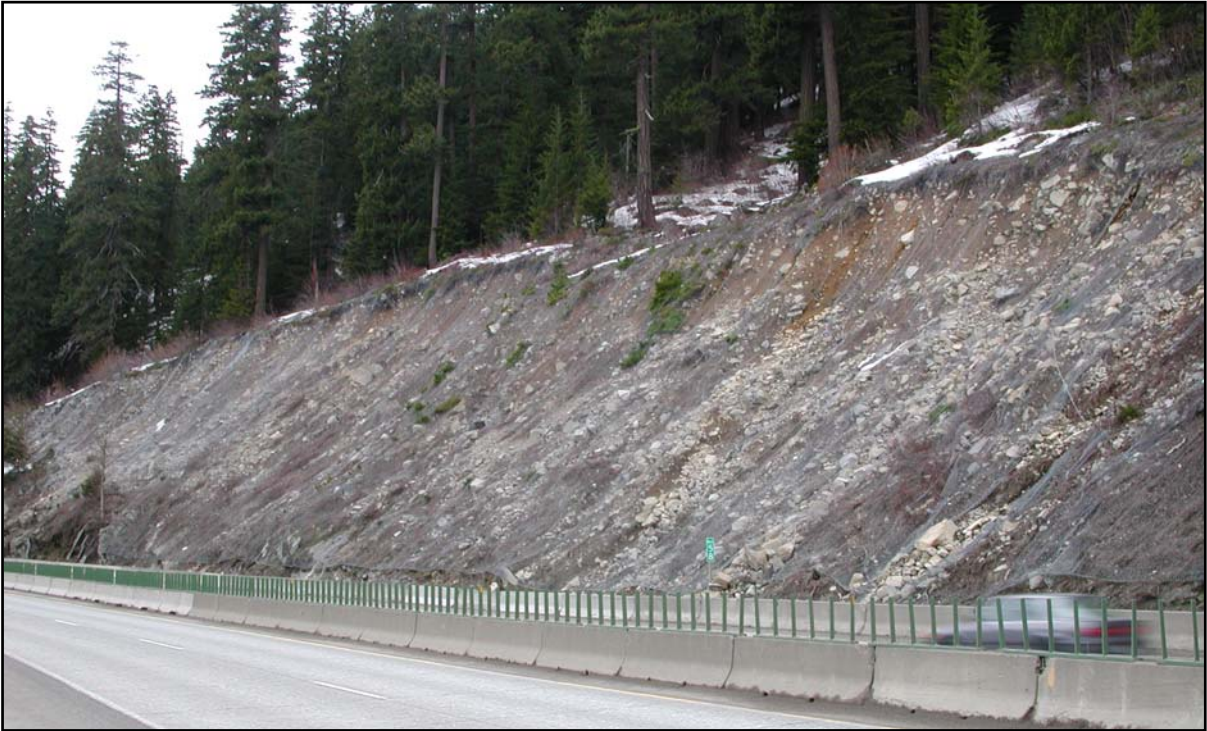
Figure 2-8. Looking west of the West Snowshed slope, active raveling near the crest of the cut slope and a large percentage of boulders within the debris.

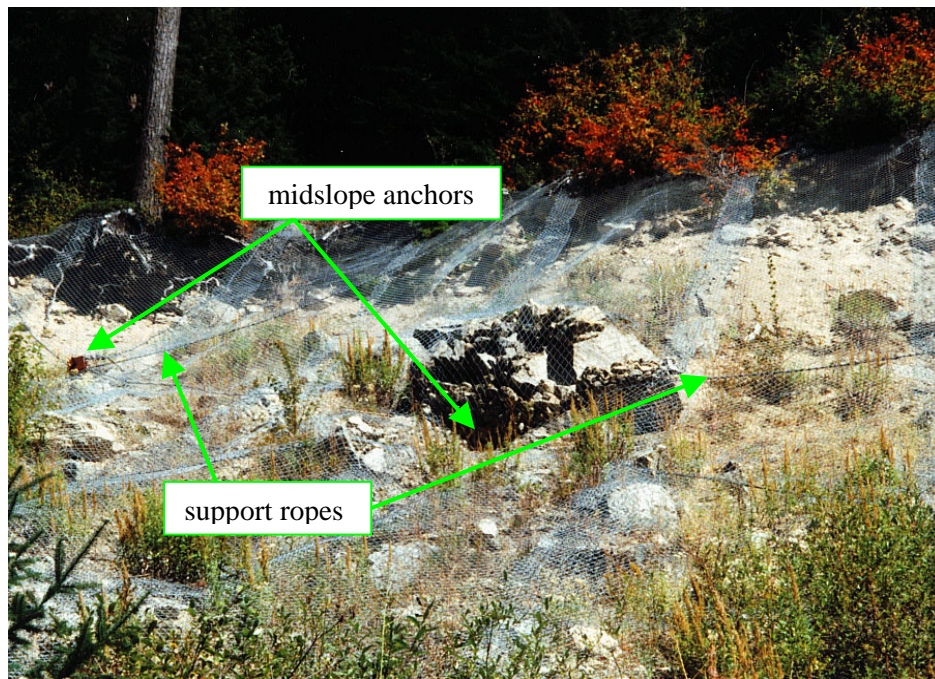
Figure 2-9. Note the large accumulation of debris at the juncture of the underlying support ropes and the midslope anchor.

After several decades of severe slope erosion and heavy snow loads, the eastern half of the first installation was badly damaged. Many seams in the chainlink had split, and localized rupture and puncture had occurred in numerous locations near the base of the installation. Support ropes also trapped large quantities of rock debris, imparting significant debris loading on the system (Figure 2-9).

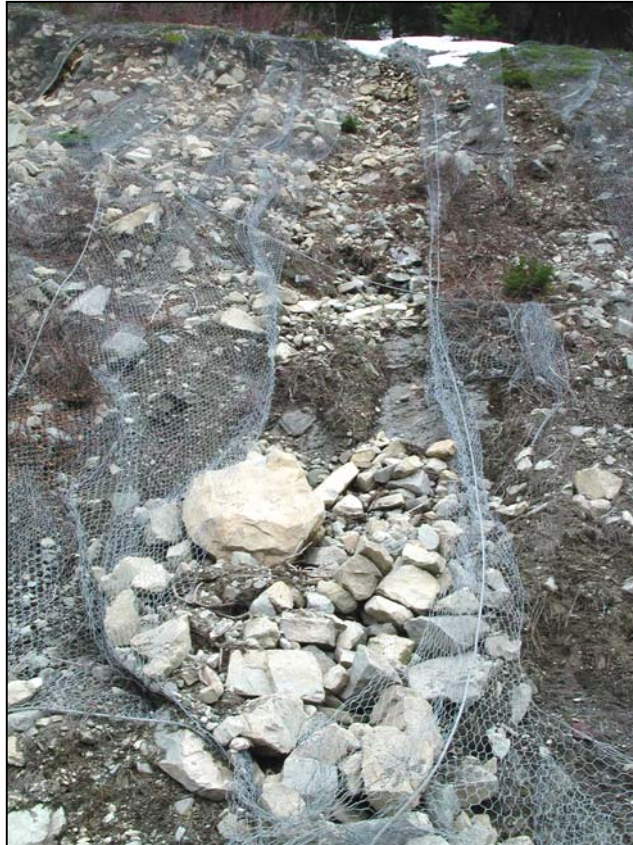
Figure 2-10. Rupture of the vertical seam and fabric; the midslope horizontal support cable was also damaged. The volume of debris associated with mesh failure is estimated to be 10 cubic yards, with block sizes of up to 3.5 feet in dimension.

Significant damage has occurred to the section that was replaced in 1998 with hexagonal wire mesh. While a different configuration of support ropes was placed on top of the mesh to better pass debris, a large quantity of debris has still accumulated beneath the lower half of the mesh (Figure 2-10).

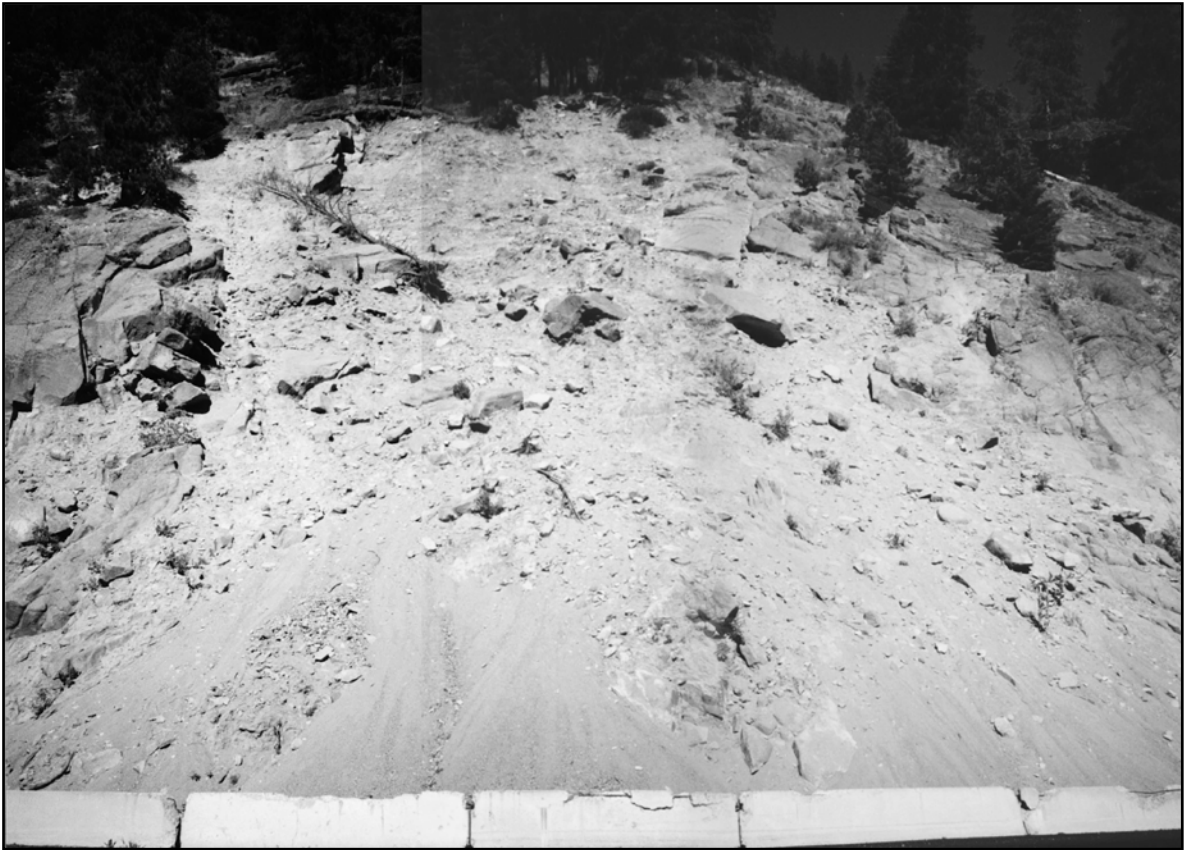
Figure 2-11. Slope condition before cable net installation; note the rockfall-related damage to the concrete barrier.

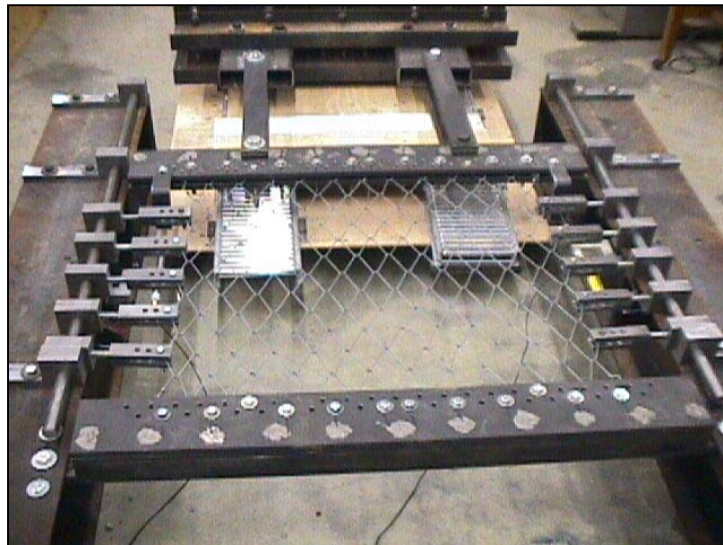
Figure 3.1. Testing apparatus with TECCO[®] mesh.

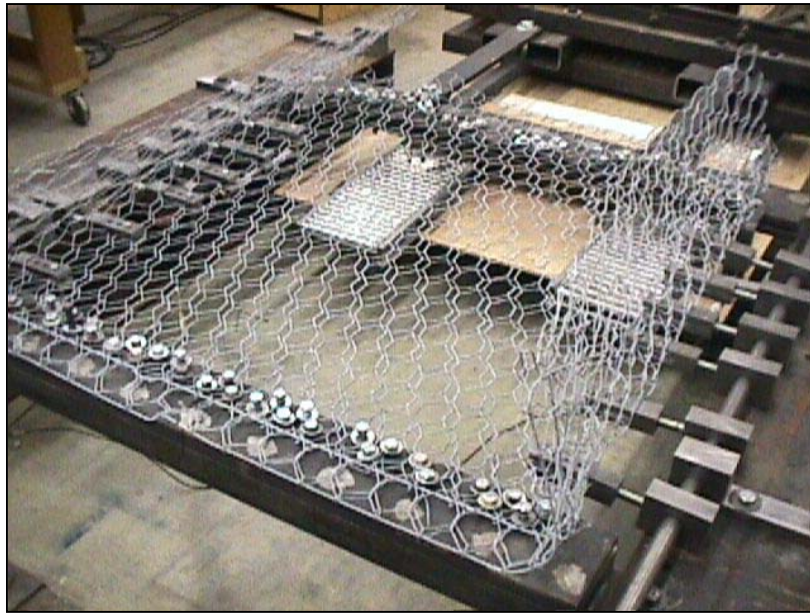
Figure 3-2. Setup for *Mac Double Galv1* mesh with bolts extended above the loading plates.

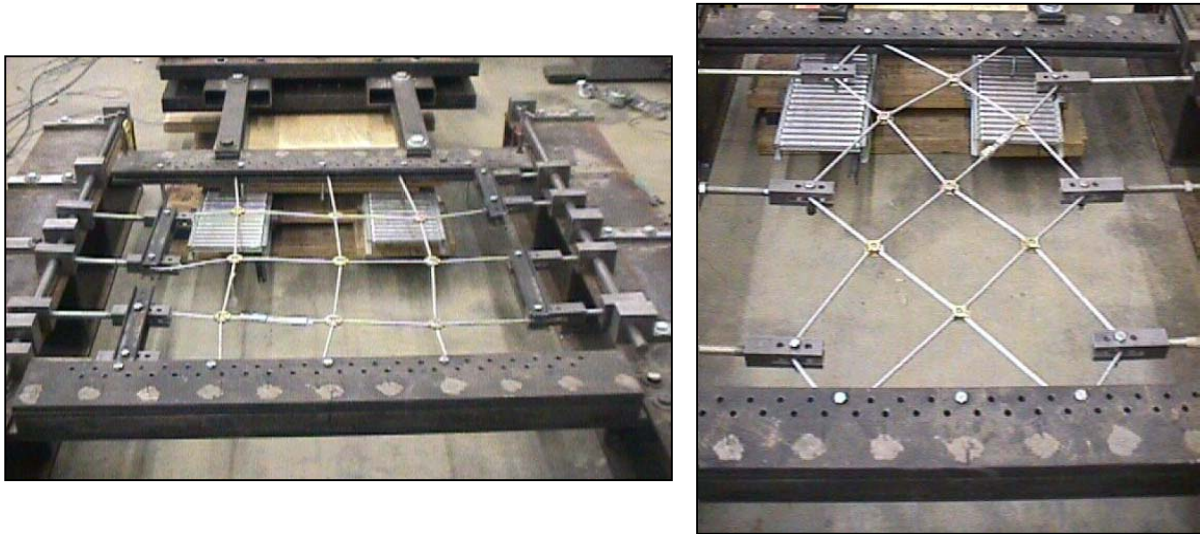
Figure 3-3. Setup for (A) Geobruigg square grid cable net and (B) Geobruigg diagonal grid cable net.

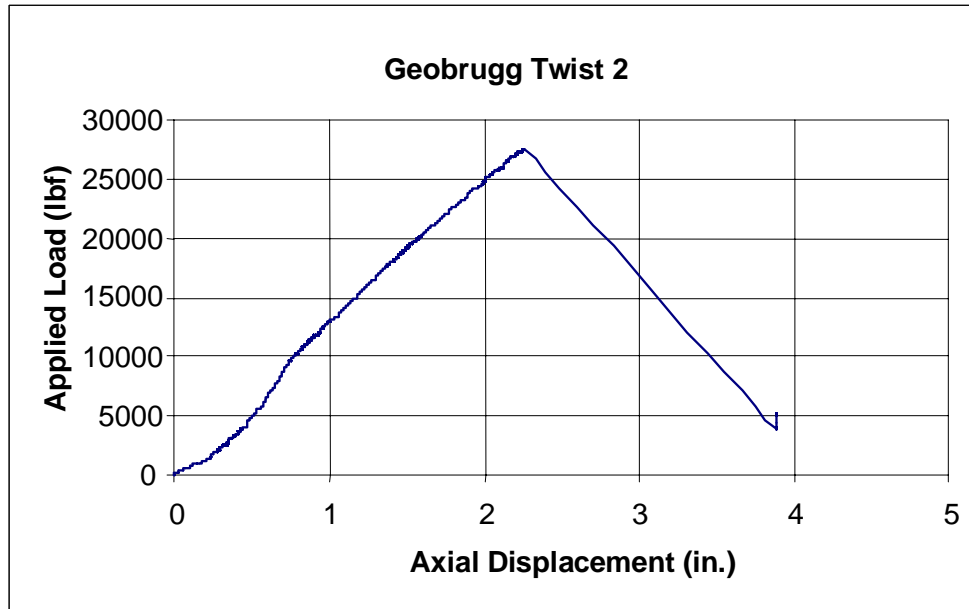
Figure 3-5. A load versus displacement graph for determining elastic modulus is shown for the TECCO® mesh.

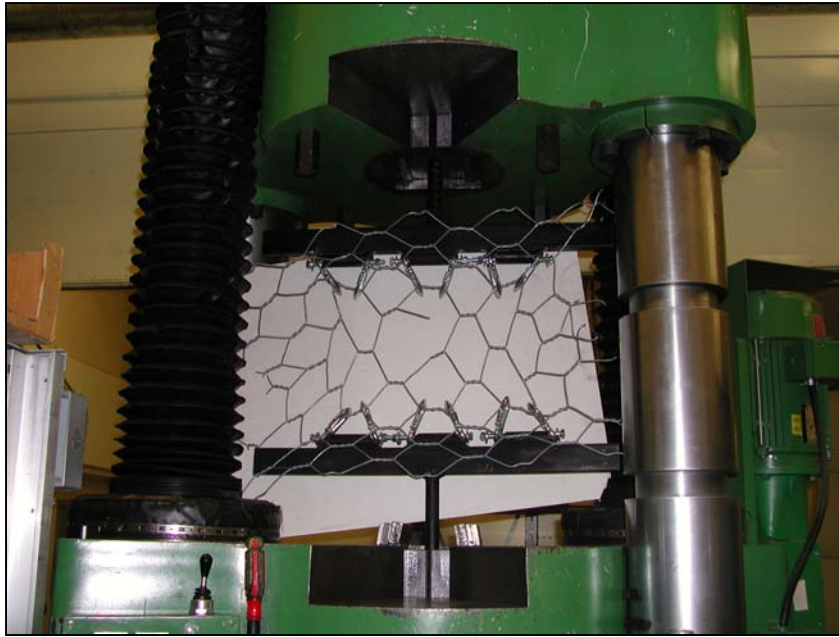
Figure 3-7. Testing/clamping apparatus and failed specimen of bulk material (no seam).

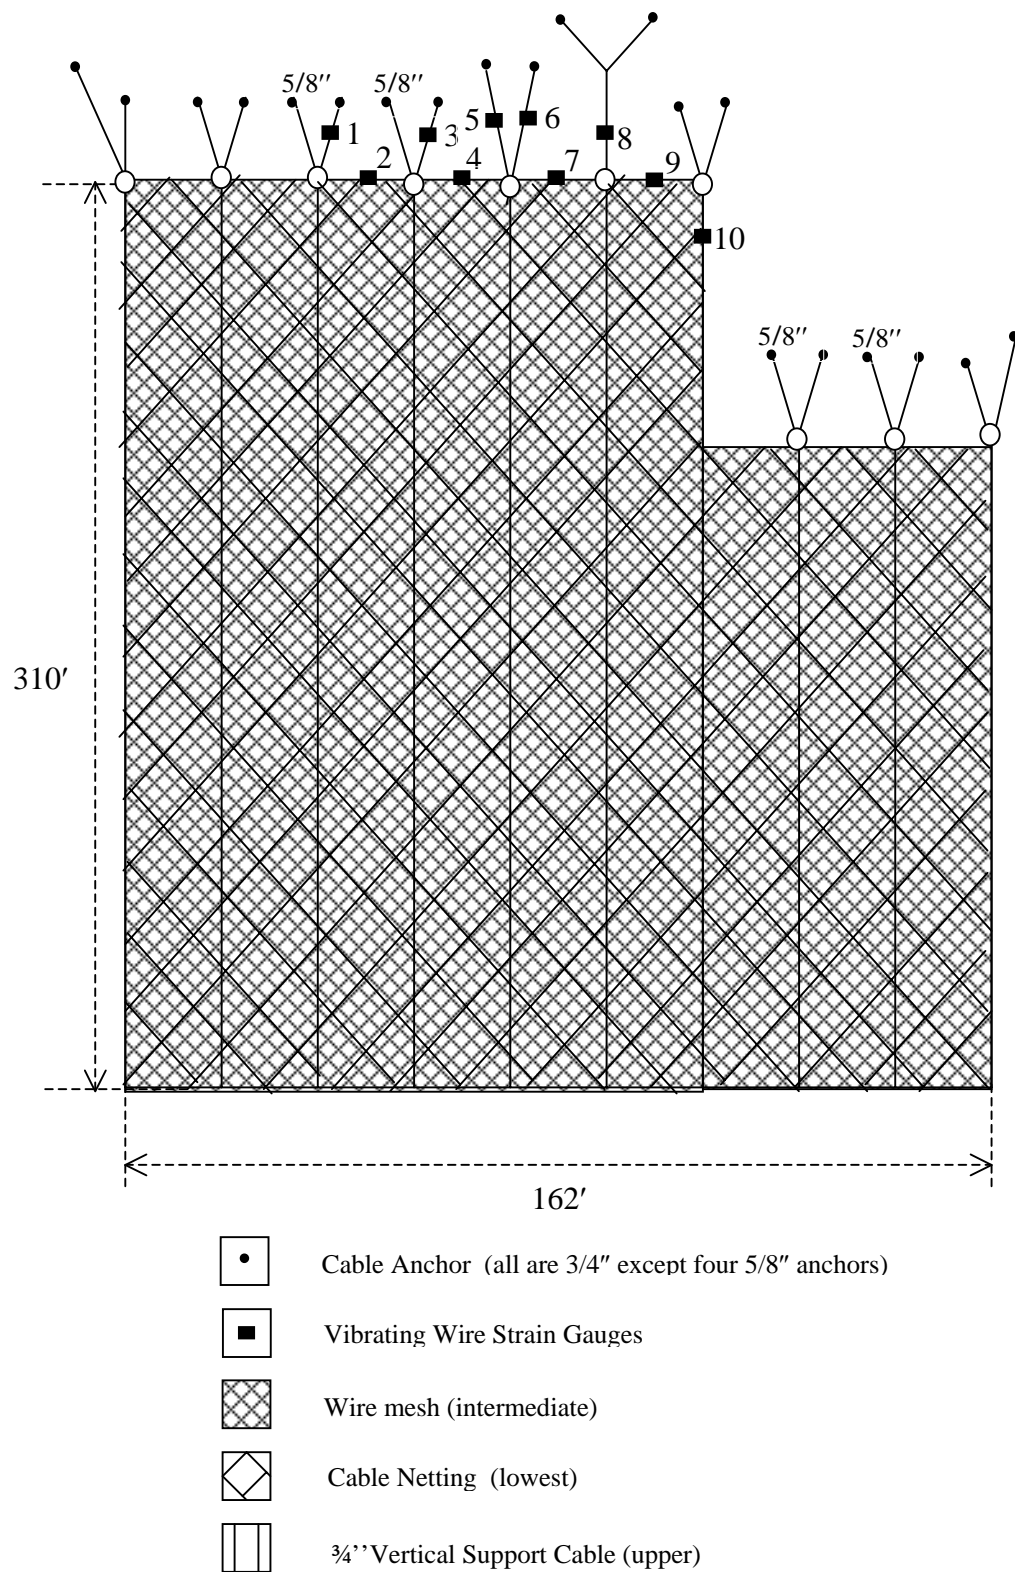
Figure 3-8. Dimensions and configuration of the cable net system and layout of the instrumentation.

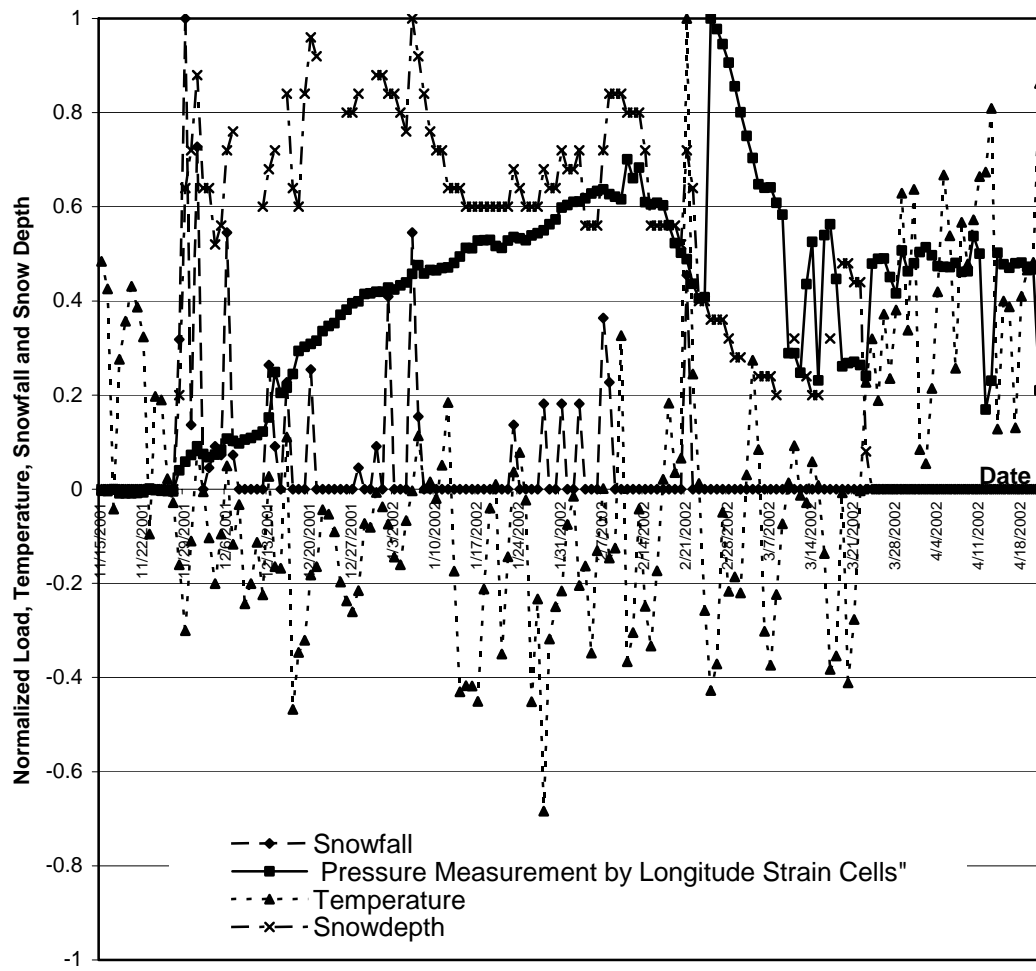
Figure 3-9. Normalized values of load for vertical (longitudinal) strain gauges, temperature, and snow depth.

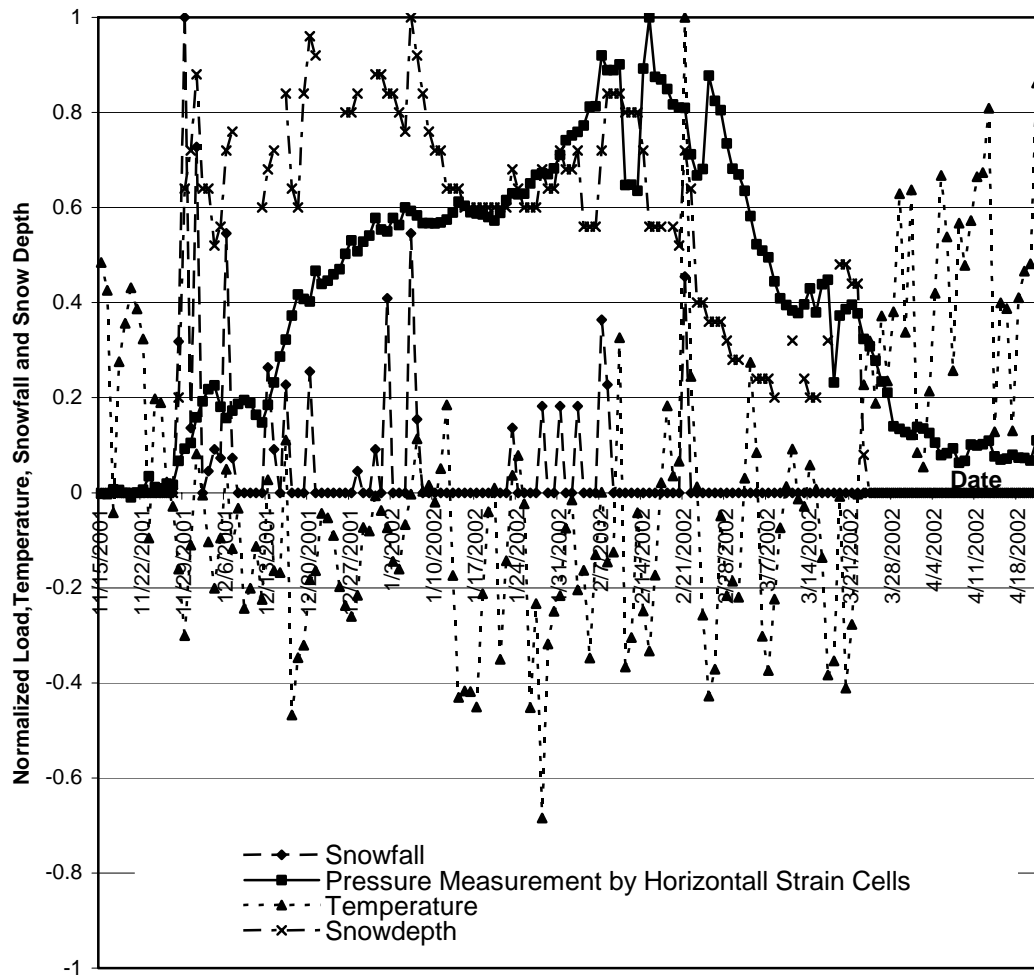
Figure 3-10. Normalized values of load for horizontal (transverse) strain gauges, temperature, and snow depth.

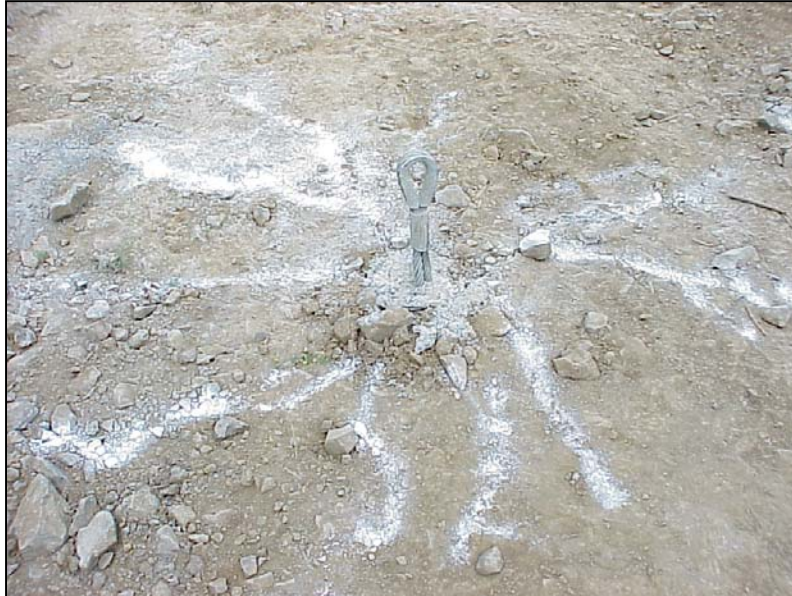
Figure 3-18. Ground cracking (white painted lines) that developed around Anchor 17 (double cable anchor) during vertical loading.

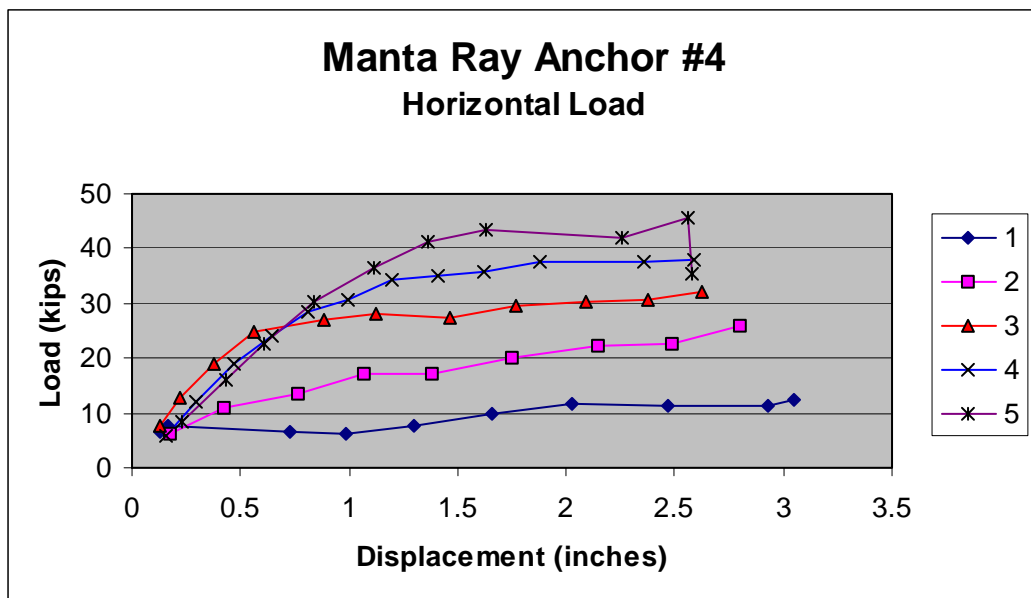
Figure 3-19. Load-displacement plot for horizontal test of a Manta Ray[®] anchor (#4).

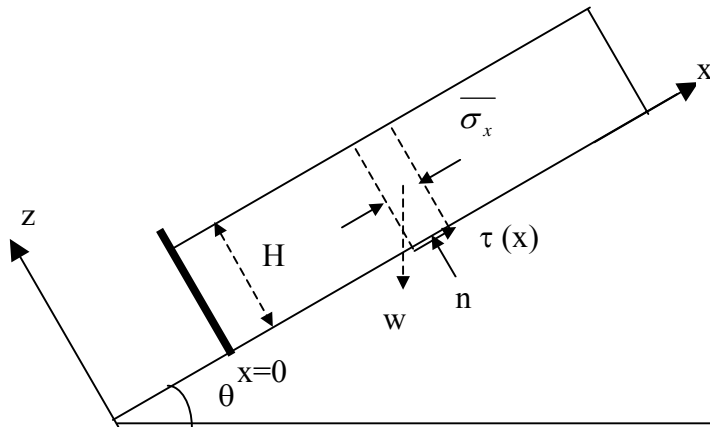
Figure 4-1. Stress components of snowpack upslope of an avalanche structure.

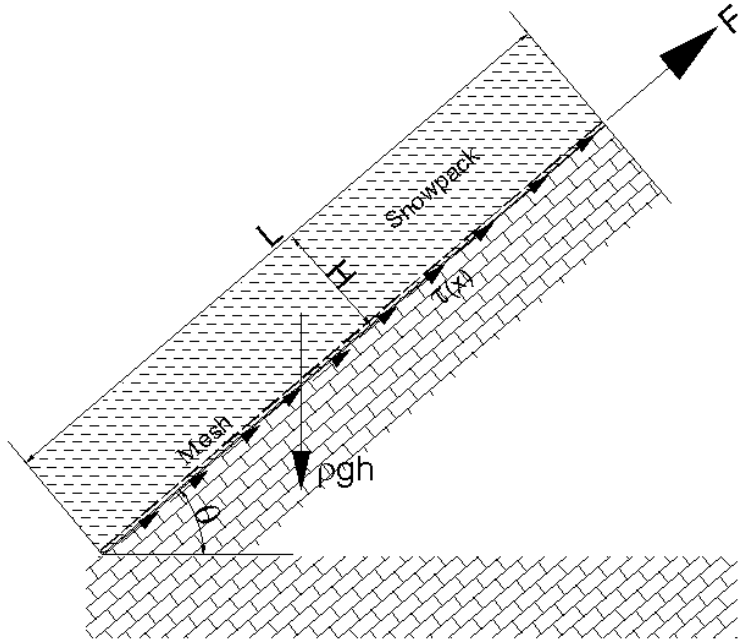
Figure 4-3: The force components of the mesh and snowpack when the snow is bonded to both to the mesh and ground. F_a is the drag force on the anchors for a section of mesh L in length.

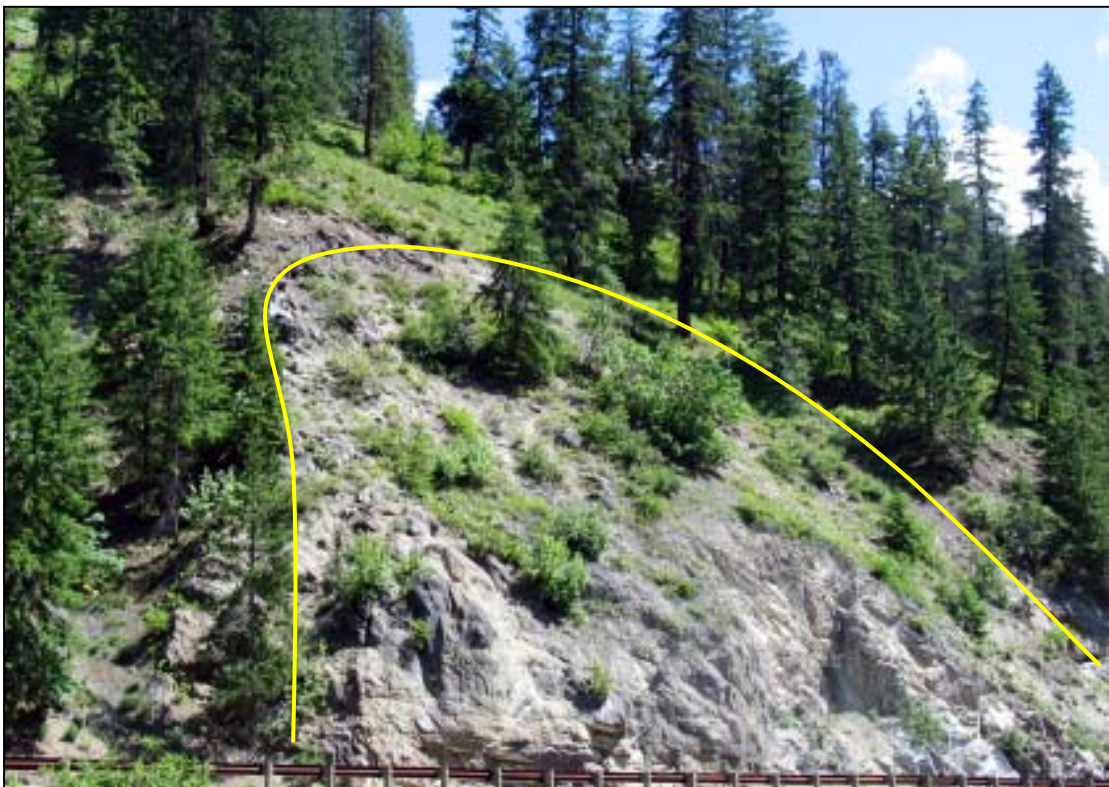
Figure 4-6: Mesh installation (yellow line) on a planar and relatively smooth slope segment upslope of the steep bedrock exposures at roadway level. Snow accumulates only on the upper slope segment.

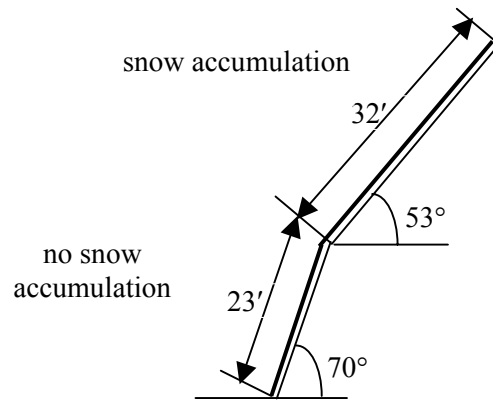
Figure 4-7: Cross-section of installation with slope configuration and area of snow accumulation.

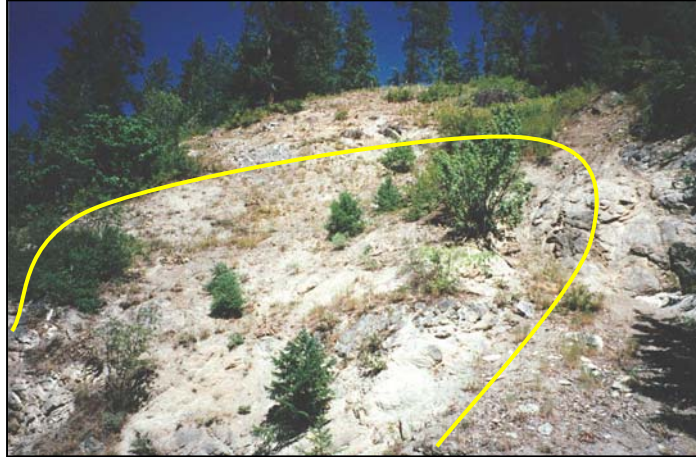
Figure 4-8. Upper slope area before 1997 installation and the area where snow accumulates. Yellow line delineates approximate coverage area of mesh. Note planar condition and absence of irregularities over much of the upper slope.

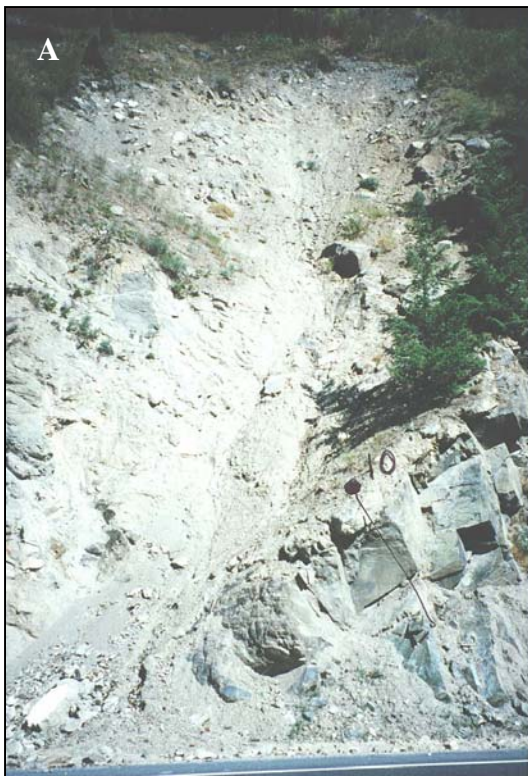
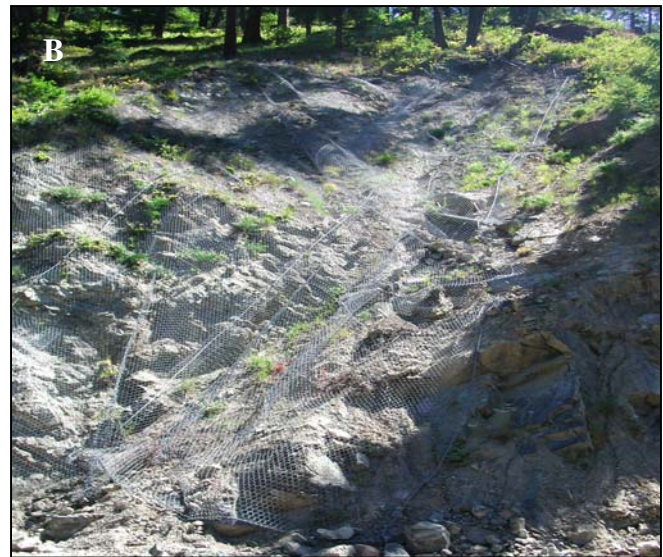
Figure 4-9. Slope area in (A) 1997 before and (B) 2002 five years after mesh installation and just after repair of the system.

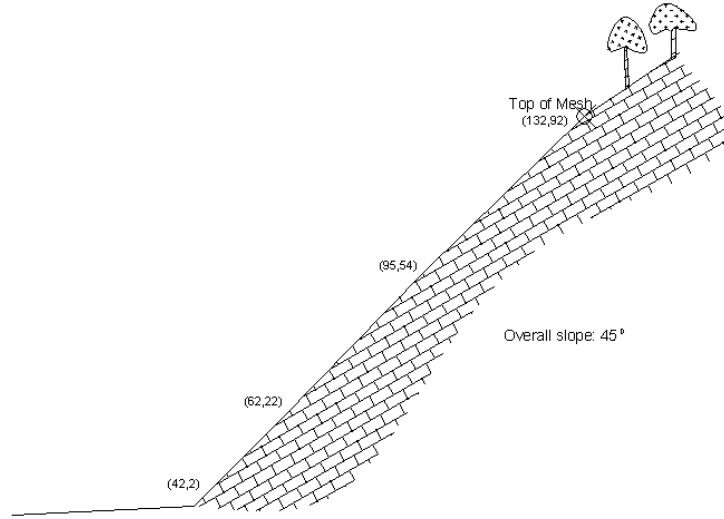
Figure 4-10. Cross-section of installation shows approximate slope configuration. Snow accumulates on the entire area of the installation.

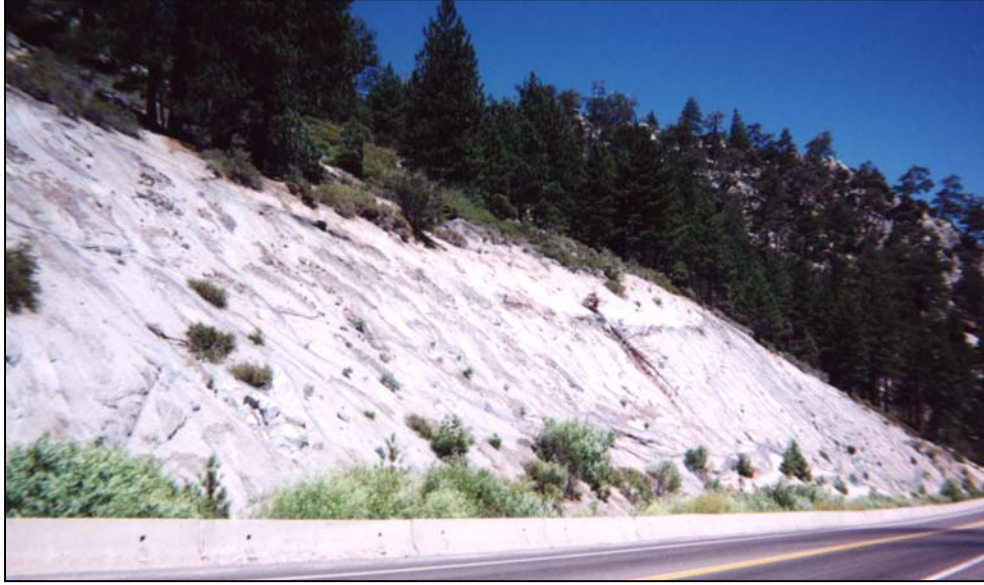
Figure 4-11. Eastern half of the damaged installation still partially suspended on the slope, held in place mostly through interface friction and the few remaining intact anchors.

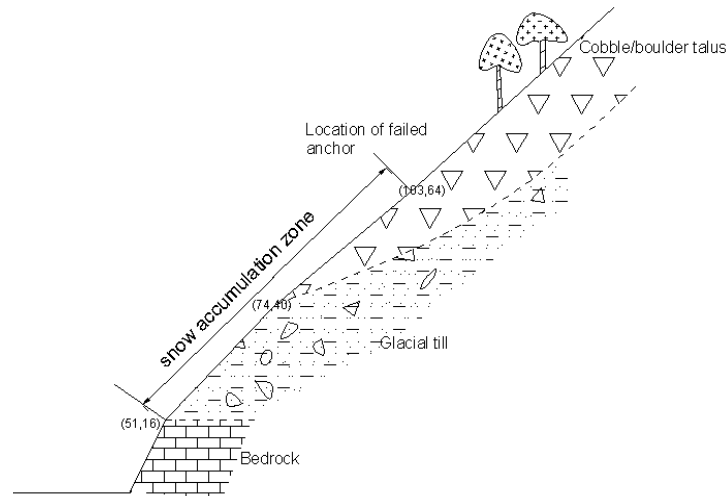
Figure 4-12. Cross-section through failed cable net shows the portion of the installation that accumulated snow. Snowpack also extended upslope of the installation. The entire slope above the bedrock portion is highly susceptible to snow avalanches.
